Multiplexer Sporadic Activity Troubleshooting

Multiplexer Sporadic Activity Troubleshooting – Page 2

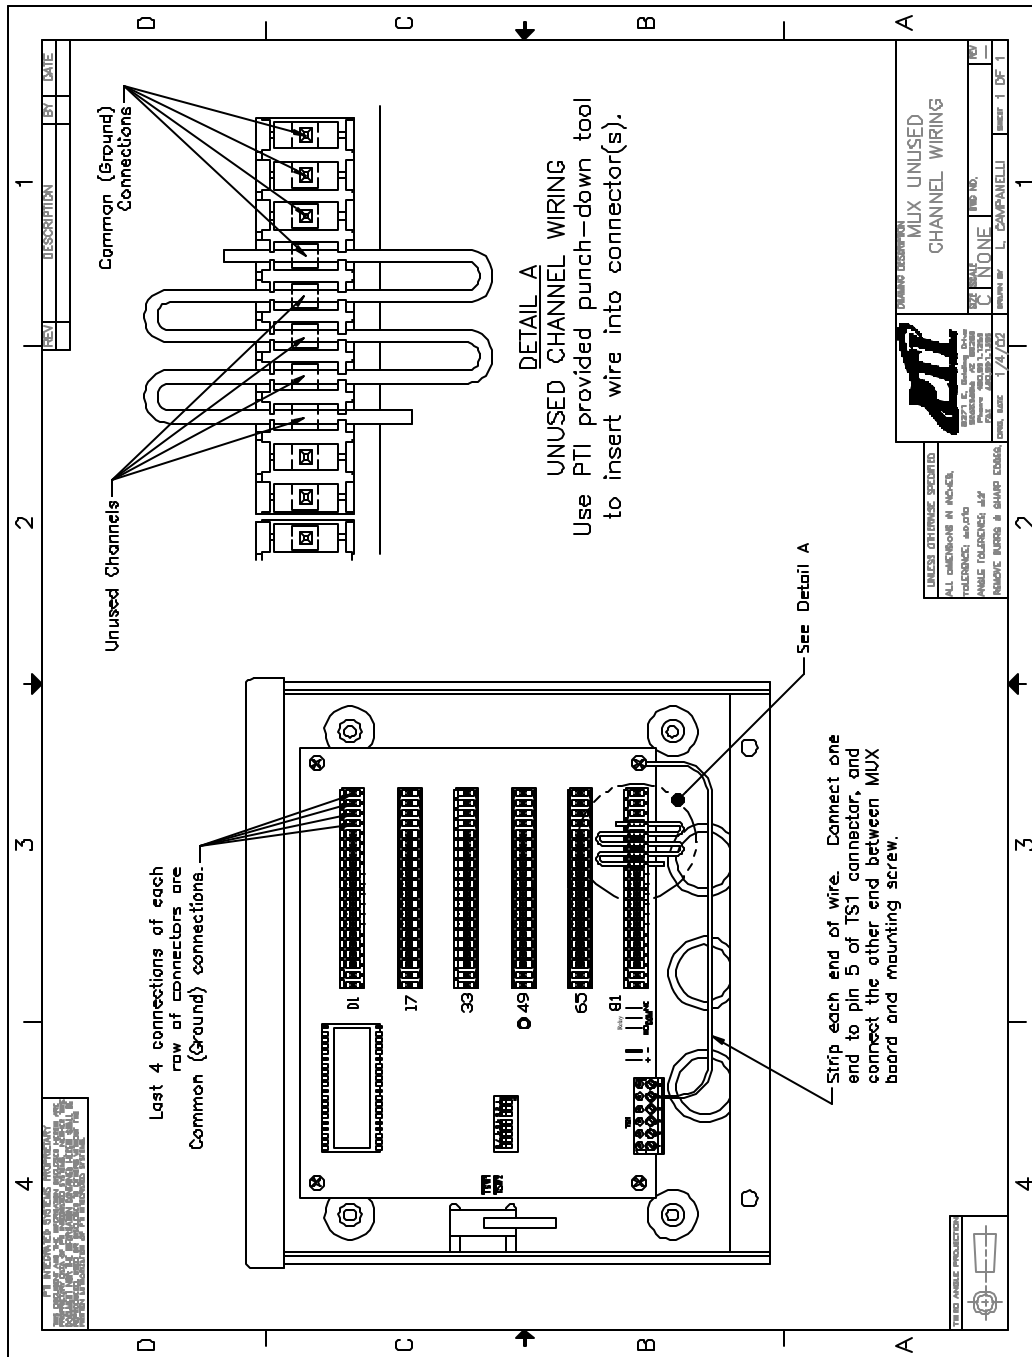
6. If the problem is occurring in channels that are not used, tie down all unused channels to Common (Ground). See drawing on page 2. Using a PTI Punch-down tool, punch down a 24ga or 22ga insulated stranded wire through any unused door alarm channels and at least one common (ground) connection. Then connect a length of 24ga or 22ga wire from pin # 5 of the power and data terminal block to one of the four screws that mount the circuit board to the metal case. The Metal case of the multiplexer must also be mounted directly to a grounded metal building or tied to a ground rod or grounded metal structural element of the building such as a metal water pipe or ground rod in accordance with local code. If at all possible both ends of the shield/ground wire should be tied to ground.
